Trillion Inspections

CONFIDENTIAL INSPECTION REPORT

Williams Ave W, Seattle, WA

10/12/2011 12:00 pm

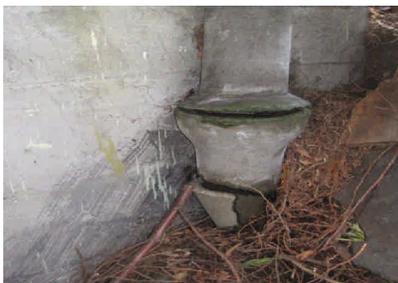
The drain for the front North downspout going underground was broken today. It is important in the long run the drains for roofs are functional, so have it repaired or replaced so they operate properly.

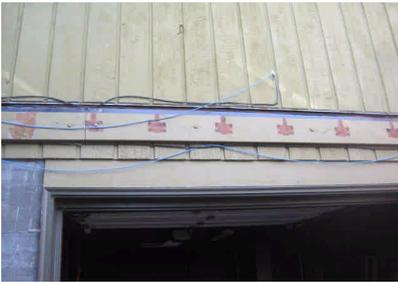
The siding in back where an old deck was needs repair ASAP. Gaps and openings can allow water into the structure. A siding specialist would be needed to repair it because the siding is so bad it not waterproof anymore.

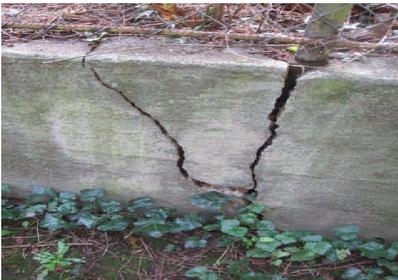
The retaining wall at the South side of the residence is cracked badly, and should be repaired soon. This can happen in several ways. Consult a wall specialist for advice.

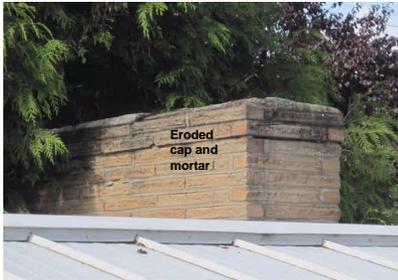
There is noticeable erosion to the mortar and cap on the North chimney. Repair as needed.

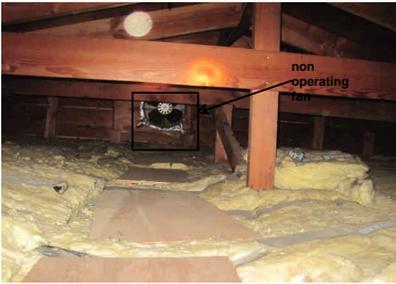
Attic fan cannot be tested - *Continued*

Attic fan cannot be tested because there is a temperature switch on it. Also, there is not only one gable vent so it should be sucking air out. It is more critical the powered vent operates in this situation.. Seller to demonstrate operation of this item by closing.

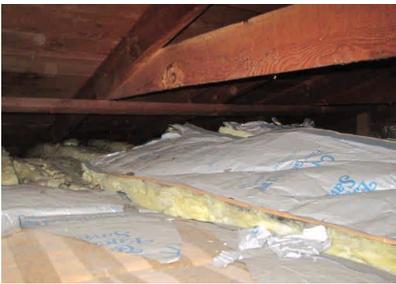
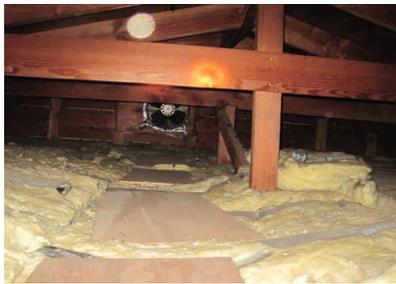
Some foil-faced batt insulation in the attic has been installed upside down, which is not technically correct. This could trap moisture over time but it is a rare condition. Since it is a possibility and not correct, we recommend reversing or removing the faced product.

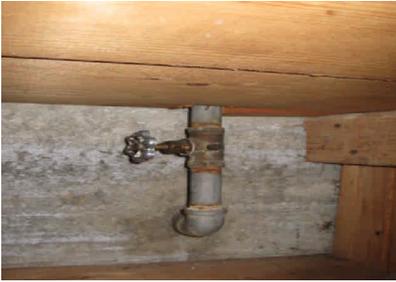
The main water shut-off valve is located in the basement.

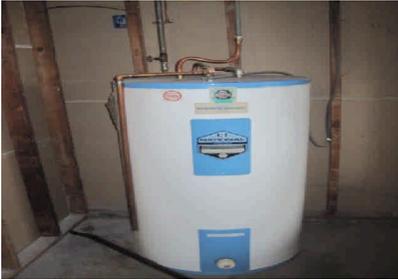
Replace the water heater tank now. The tank is 32 years past its expected life of 15 years.

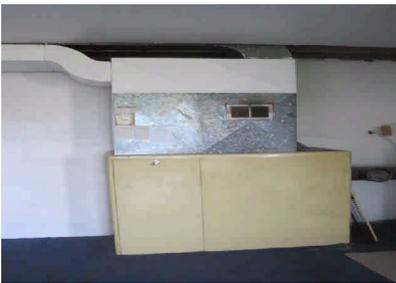
The furnace past its expected life of 40 years. We recommend it gets replaced as soon as possible. There is rust and corrosion inside and the heat exchanger could be at the end of its life.

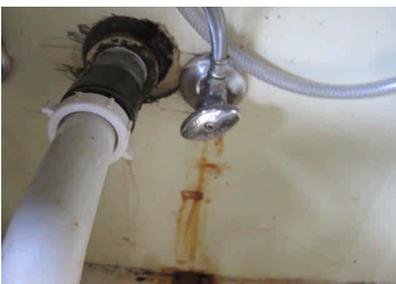
There is a leak on the cold-water shut-off valve below the sink, which should be repaired.

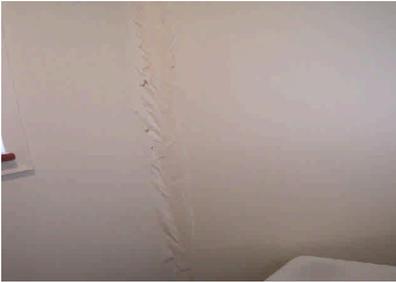
There is moisture damaged to the wall and ceiling over the basement bath toilet, which is not uncommon but which should be repaired. No leaks today. It looks be from an old leak in the upstairs bath supply line.
